Manotick Pathways Inventory Notes

MANOTICK CENTENNIAL PARK - PATHWAY UPGRADES

Dr Leach Drive, Manotick

INVENTORY PLAN

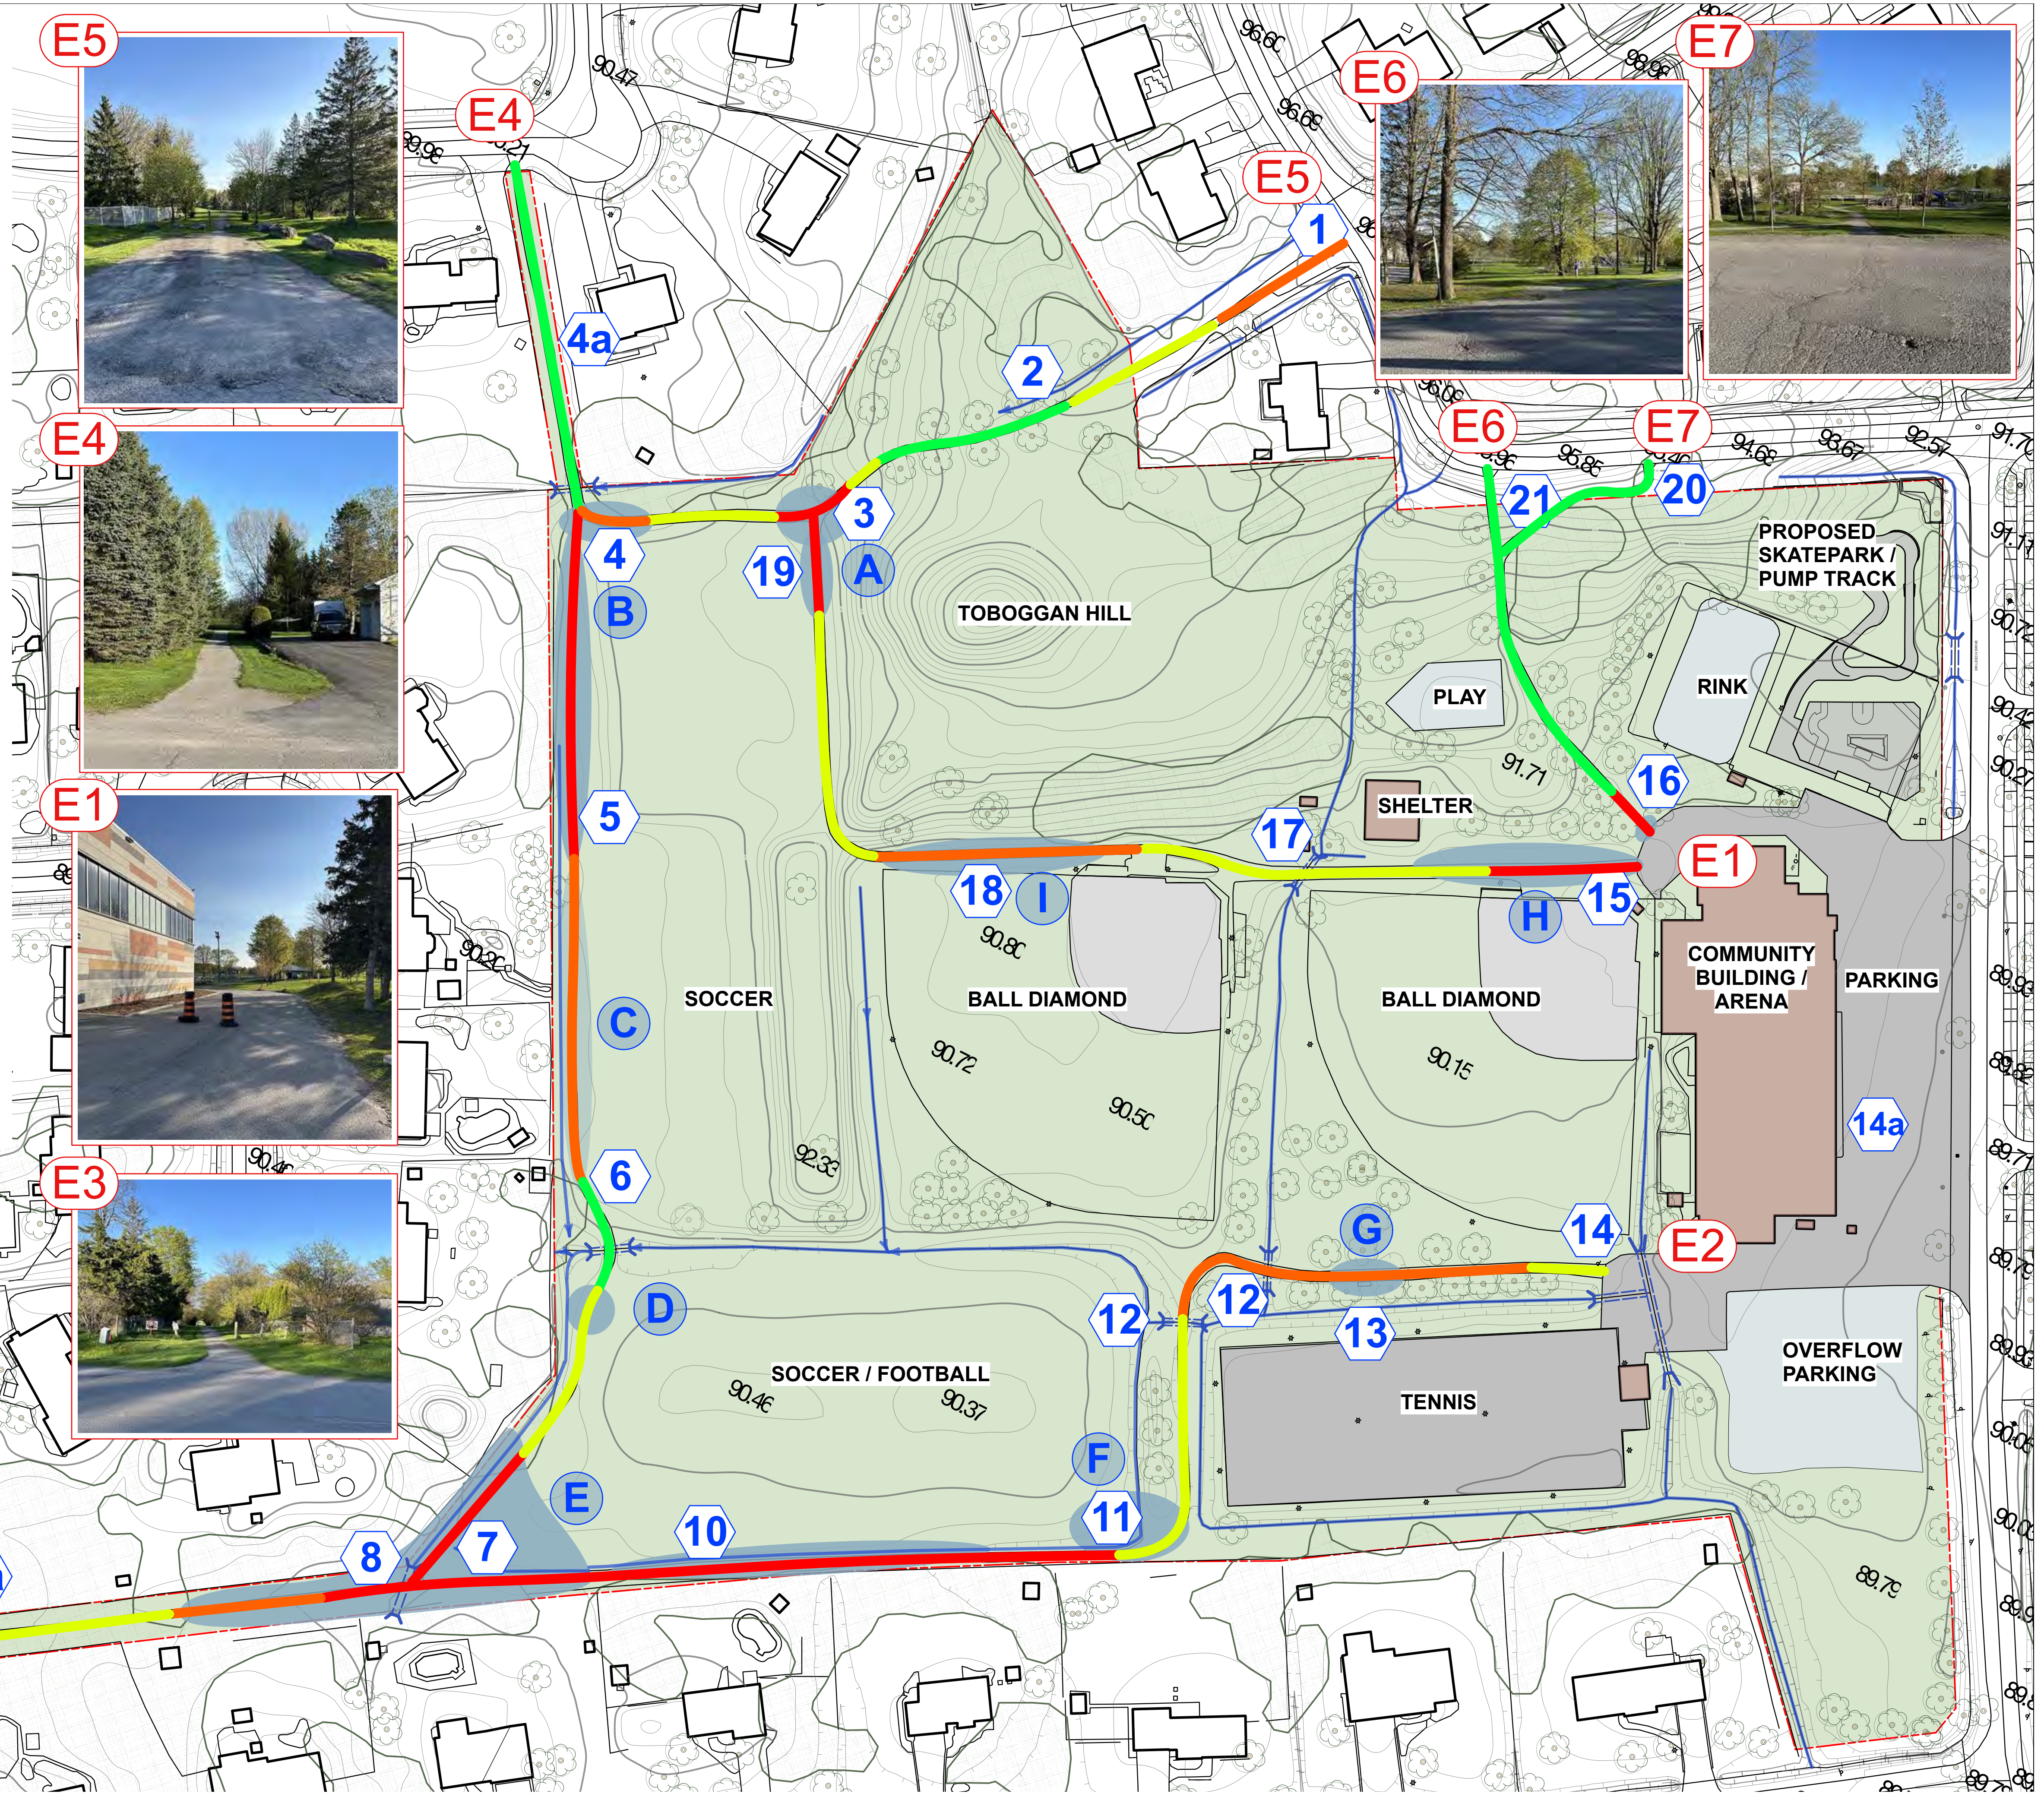
- 1 Entrance at Beaverwood Road: Small section of asphalt at road - in poor shape, not accessible. Bollards in poor shape.
- 2 Stonedust path 1.2-1.5 m wide upgraded here, in fairly good shape.

- 3 Erosion down path and at path intersection (low spot / not draining at intersection).
- 4 Very low and wet area (not draining).
- 5 Narrow path, shallow swale at property line (not draining).

- 6 Culvert at bend in path. Sump pump from adjacent house outlets here. Granular swale at culvert and extends south. Path ±900mm wide.
- 7 Swale overflows onto pathway.

- 8 Box end type drain - blocked or no slope? Culvert exposed on path, ends into Catch Basin. Water is not flowing.
- 9 Entrance at Beaverwood Road (west): Small section of asphalt at road - in poor shape, ±1.0 metre in width.

- 10 Section very wet, still snow here where most other places has melt. Swale not well defined, not draining. Lowest point at south end.
- 11 Low point and wet at bend in path, no drainage

- 12 2 culverts, both exposed, path uneven.
- 13 Low spot at bench.
- 14 Path connection to parking, culvert at swale. Area is not well defined with poor surfacing at parking lot connection.

- 15 Large low area behind addition – across pathway. Ground very uneven.
- 16 Broken asphalt, uneven ground at path junction.
- 17 Culvert exposed at pathways, drier here between ball diamonds.

- 18 Wet area – upper 'plateau' area with no drainage, no well defined swale.
- 19 Low spot near pathway junction. Path silted up from erosion (#3).
- 20 Upper pathway connection at Beaverwood: steep connection to road, not not accessible. No wet areas.

- 21 Second upper pathway connection at Beaverwood: very steep connection, not accessible.

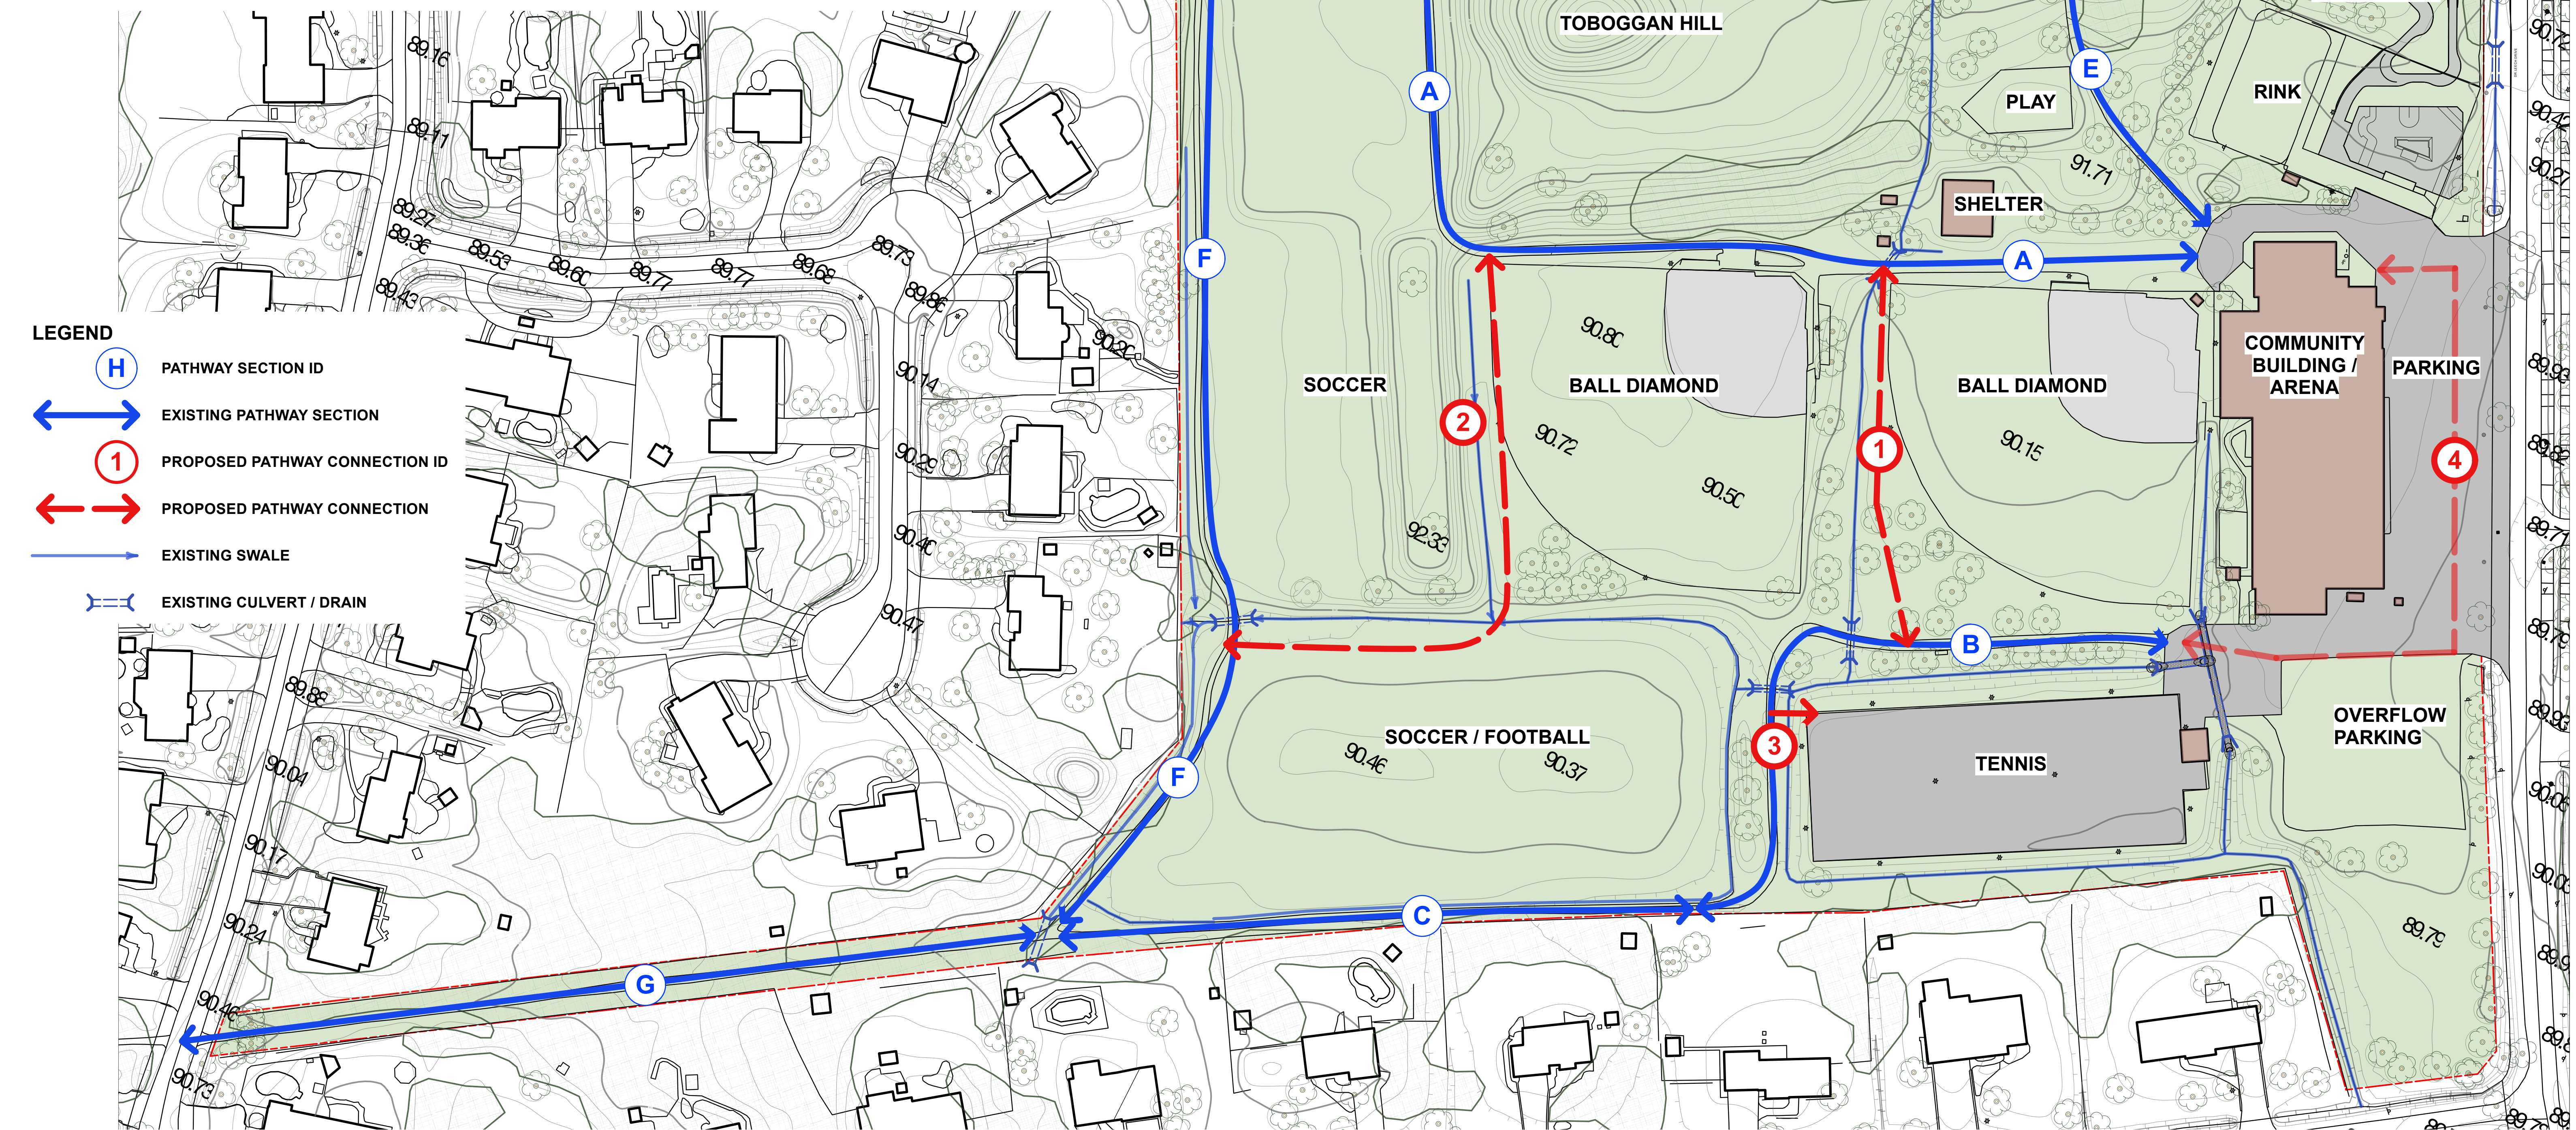
ANALYSIS PLAN

NOTES	floods @ ball diamond infield closest to bldg	swale defined near bldg, no swale at field	swale defined near bldg, no swale at field	erosion at pathway junction to A	steep at road, safety concern @ bend in road?	adjacent sump pumps flow into swale	drain @ Pathway B, E & F intersection

ITEM - NEW ACCESS ROUTES / PATHWAYS	PATHWAY SECTION 1	PATHWAY SECTION 2	PATHWAY SECTION 3	PATHWAY SECTION 4
SCOPE	WITHIN PROJECT SCOPE	WITHIN PROJECT SCOPE	WITHIN PROJECT SCOPE	FUTURE
FEASIBILITY TO INSTALL	MEDIUM	DIFFICULT	EASY	N/A
INSTALL TO AODA COMPLIANCE	YES	YES	YES	N/A
DISRUPT ADJACENT ACTIVITIES	NO	NO	NO	N/A
POSSIBLE IMPACT ON TREES	MEDIUM	LOW	N/A	N/A
ADJUST CULVERTS / SWALES	YES	YES	YES	N/A
NOTES	Alignment of path to be verified to ascertain minimal impact on existing trees. Culvert to be adjusted to allow connection to Path A	Alignment of path to be verified to ascertain if attainable near playing fields. Culvert to be added.	Connection to gate at tennis courts from side with minimal grade difference and impact. May require culvert or swale adjustment	Future possibility when upgrades to parking is considered (not part of this scope)

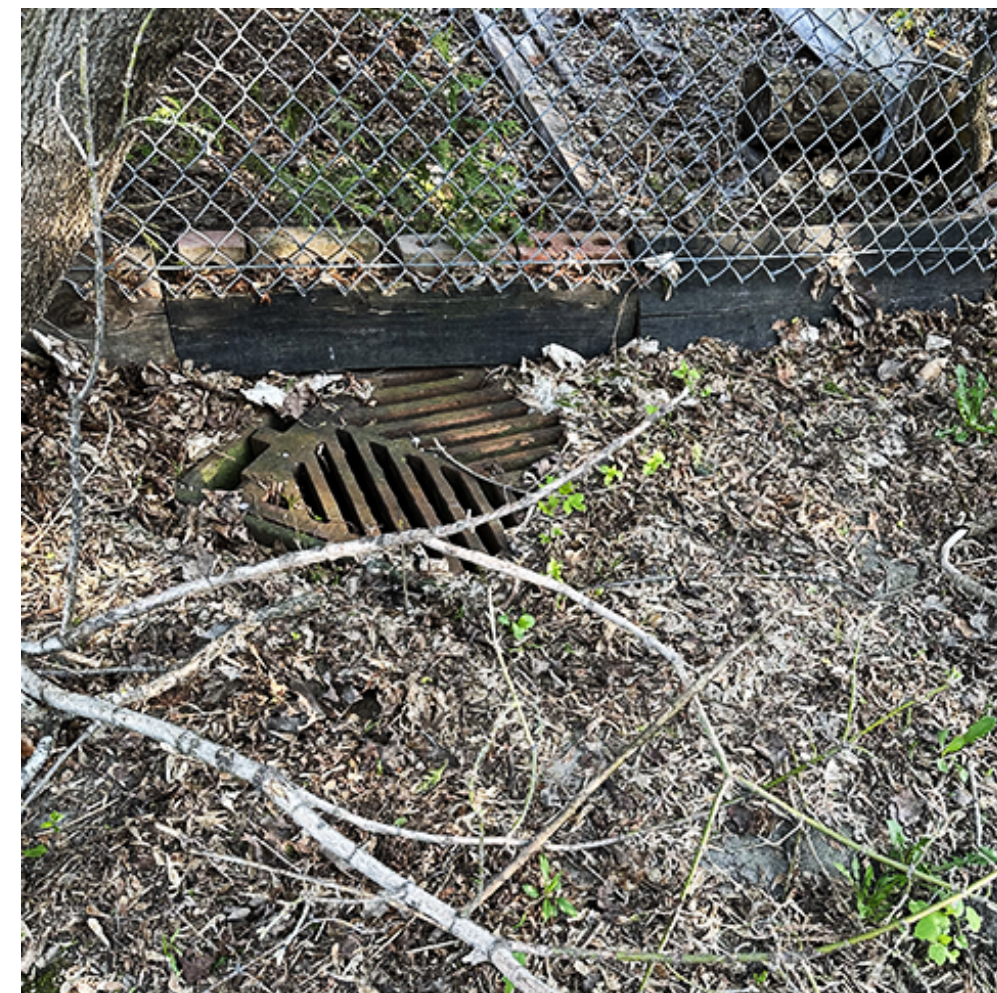
CATCH BASIN

Further study can determine whether catch basins can be added to alleviate some of the drainage issues and poor performance of existing catch basin in existing low area E. Installation and/or upgrades of existing catch basins would entail a major investment for design and installation.
