MCPRA MANOTICK CENTENNIAL PARK PATHWAY ENHANCEMENT PROJECT

Ruhland & Associates Ltd. have been retained to review the pathway systems within Centennial Park and connections to the wider neighbourhood. Site visits were undertaken in April and May of 2023 to assess the conditions of the existing pathways.

MANOTICK CENTENNIAL PARK - PATHWAY UPGRADES

Dr Leach Drive, Manotick

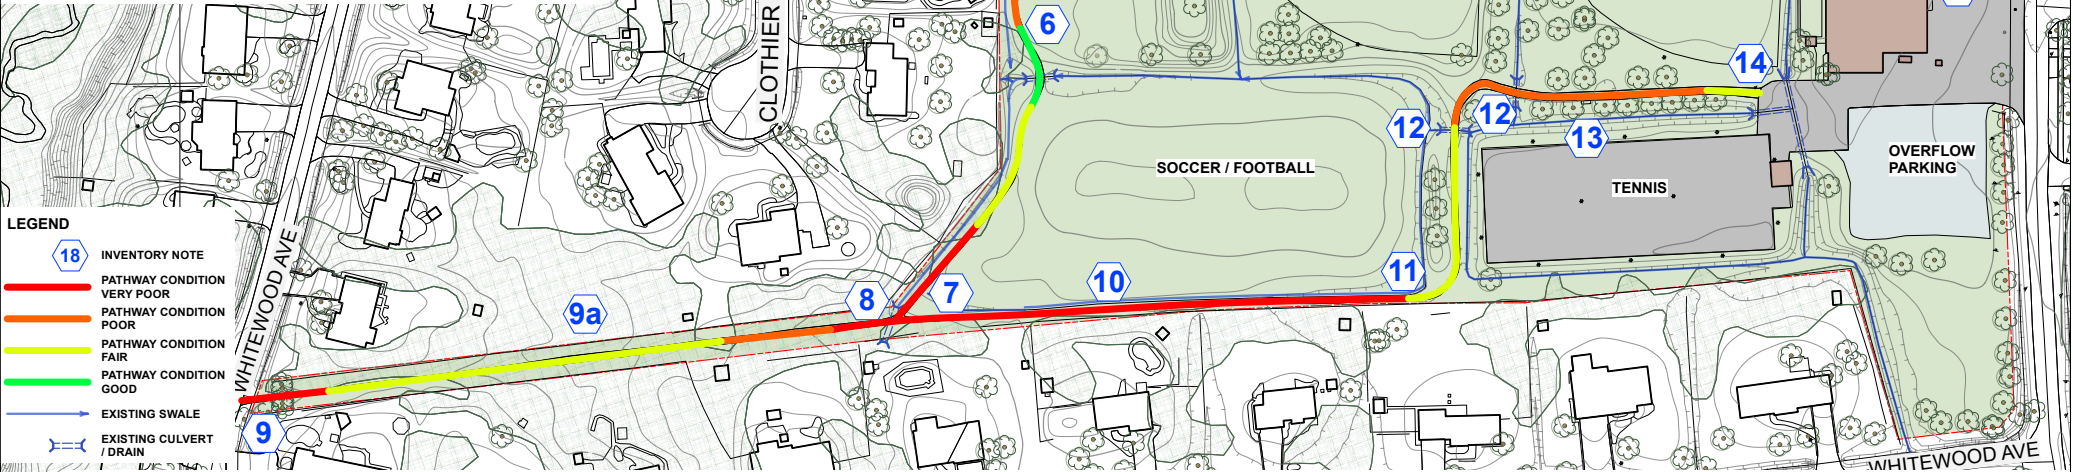
INVENTORY PLAN - NOTES

- 1 Entrance at Beaverwood Road: Small section of asphalt at road - in poor shape, not accessible. Bollards in poor shape.
- 2 Stonedust path 1.2-1.5 m wide upgraded here, in fairly good shape.

- 3 Erosion down path and at path intersection (low spot / not draining at intersection).
- 4 Very low and wet area (not draining).
- 5 Narrow path, shallow swale at property line (not draining).

- 6 Culvert at bend in path. Sump pump from adjacent house outlets here. Granular swale at culvert and extends south. Path ± 900 mm wide.
- 7 Swale overflows onto pathway.

- 8 Box end type drain - blocked or no slope? Culvert exposed on path, ends into Catch Basin. Water is not flowing.
- 9 Entrance at Beaverwood Road (west): Small section of asphalt at road - in poor shape, ± 1.0 metre in width.

- 10 Section very wet, still snow here where most other places has melt. Swale not well defined, not draining. Lowest point at south end.
- 11 Low point and wet at bend in path, no drainage

- 12 2 culverts, both exposed, path uneven.
- 13 Low spot at bench.
- 14 Path connection to parking, culvert at swale. Area is not well defined with poor surfacing at parking lot connection.

- 15 Large low area behind addition - across pathway. Ground very uneven.
- 16 Broken asphalt, uneven ground at path junction.
- 17 Culvert exposed at pathways, drier here between ball diamonds.

- 18 Wet area - upper 'plateau' area with no drainage, no well defined swale.
- 19 Low spot near pathway junction. Path silted up from erosion (#3).
- 20 Upper pathway connection at Beaverwood: steep connection to road, not not accessible. No wet areas.

- 21 Second upper pathway connection at Beaverwood: very steep connection, not accessible.

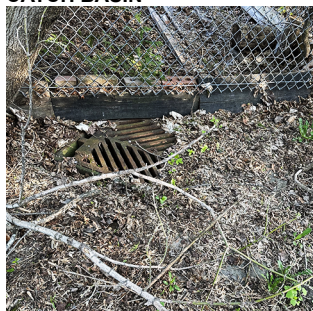
CATCH BASIN

Further study can determine whether catch basins can be added to alleviate some of the drainage issues and poor performance of existing catch basin in existing low area E. Installation and/or upgrades of existing catch basins would entail a major investment for design and installation.
