Manotick Pathways Inventory Notes

MANOTICK CENTENNIAL PARK - PATHWAY UPGRADES

Dr Leach Drive, Manotick

INVENTORY PLAN

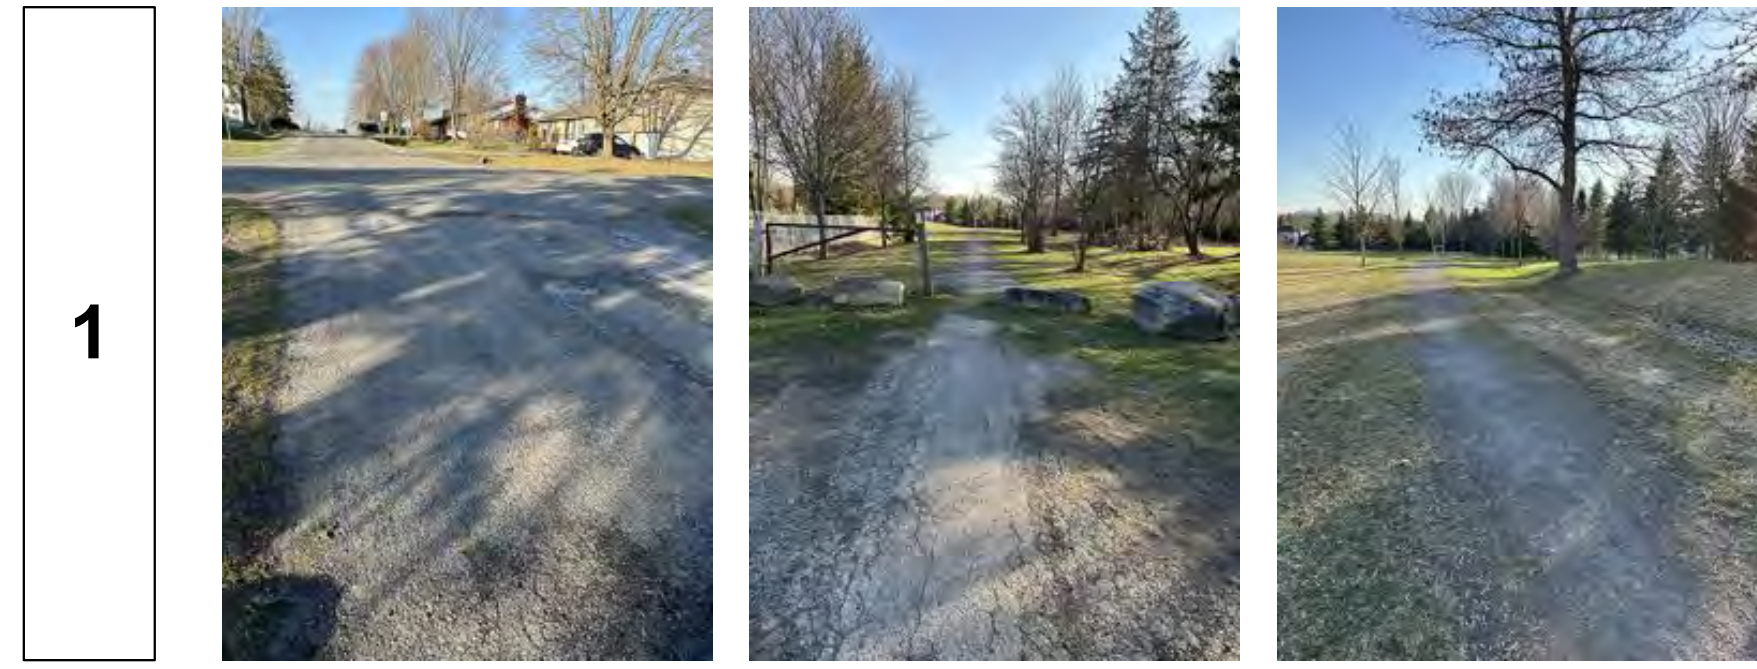
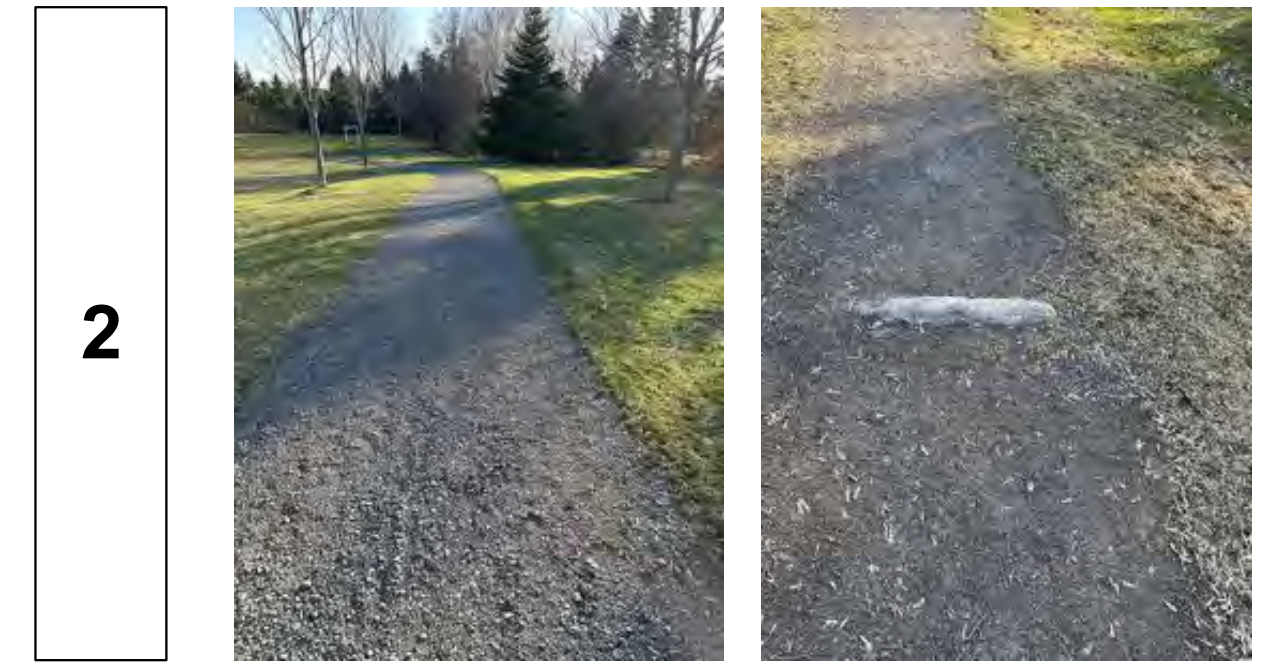
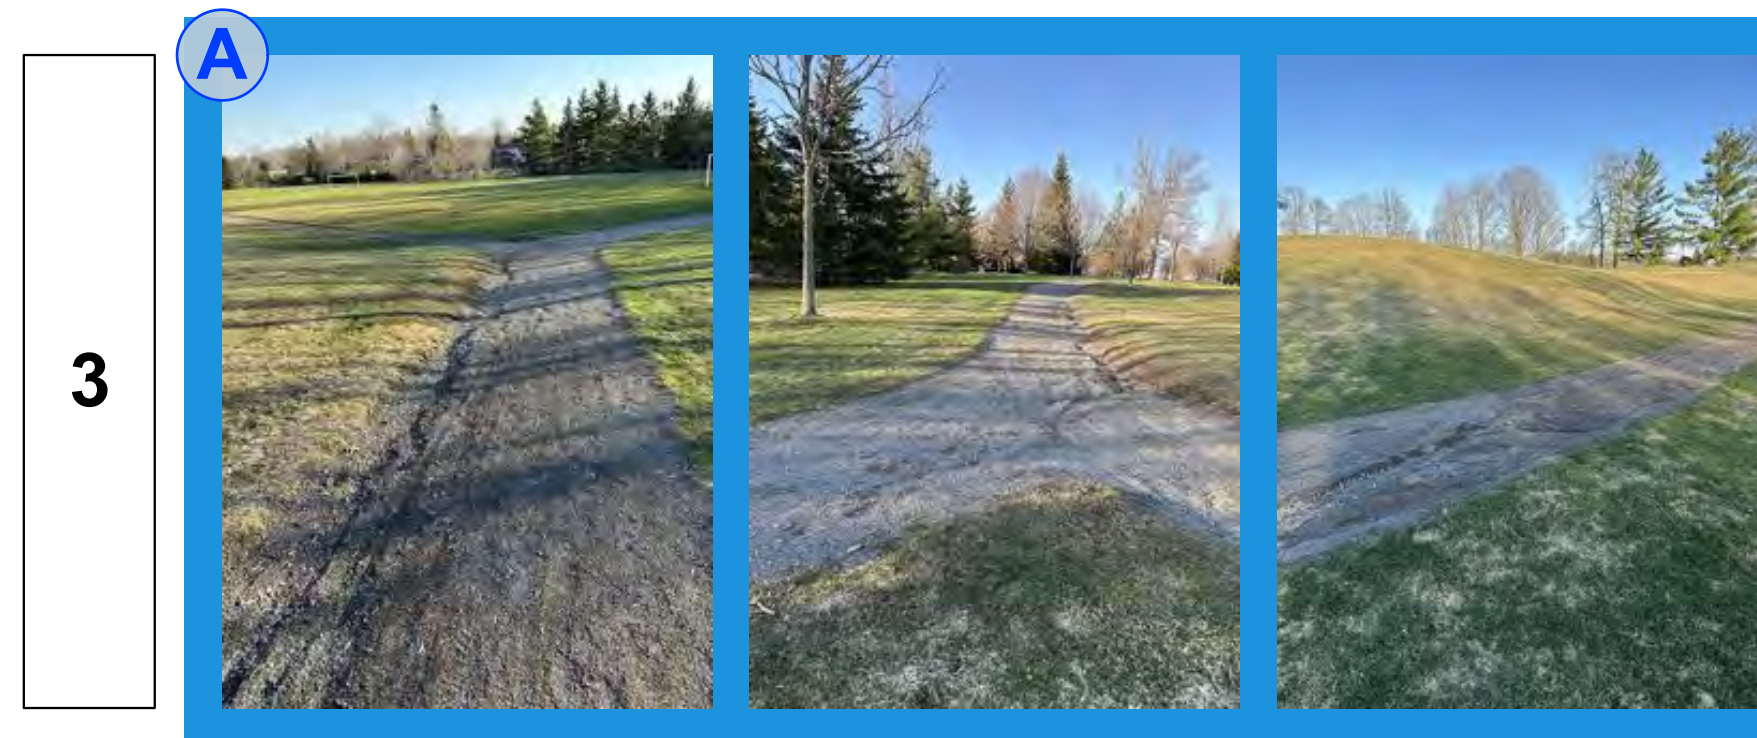
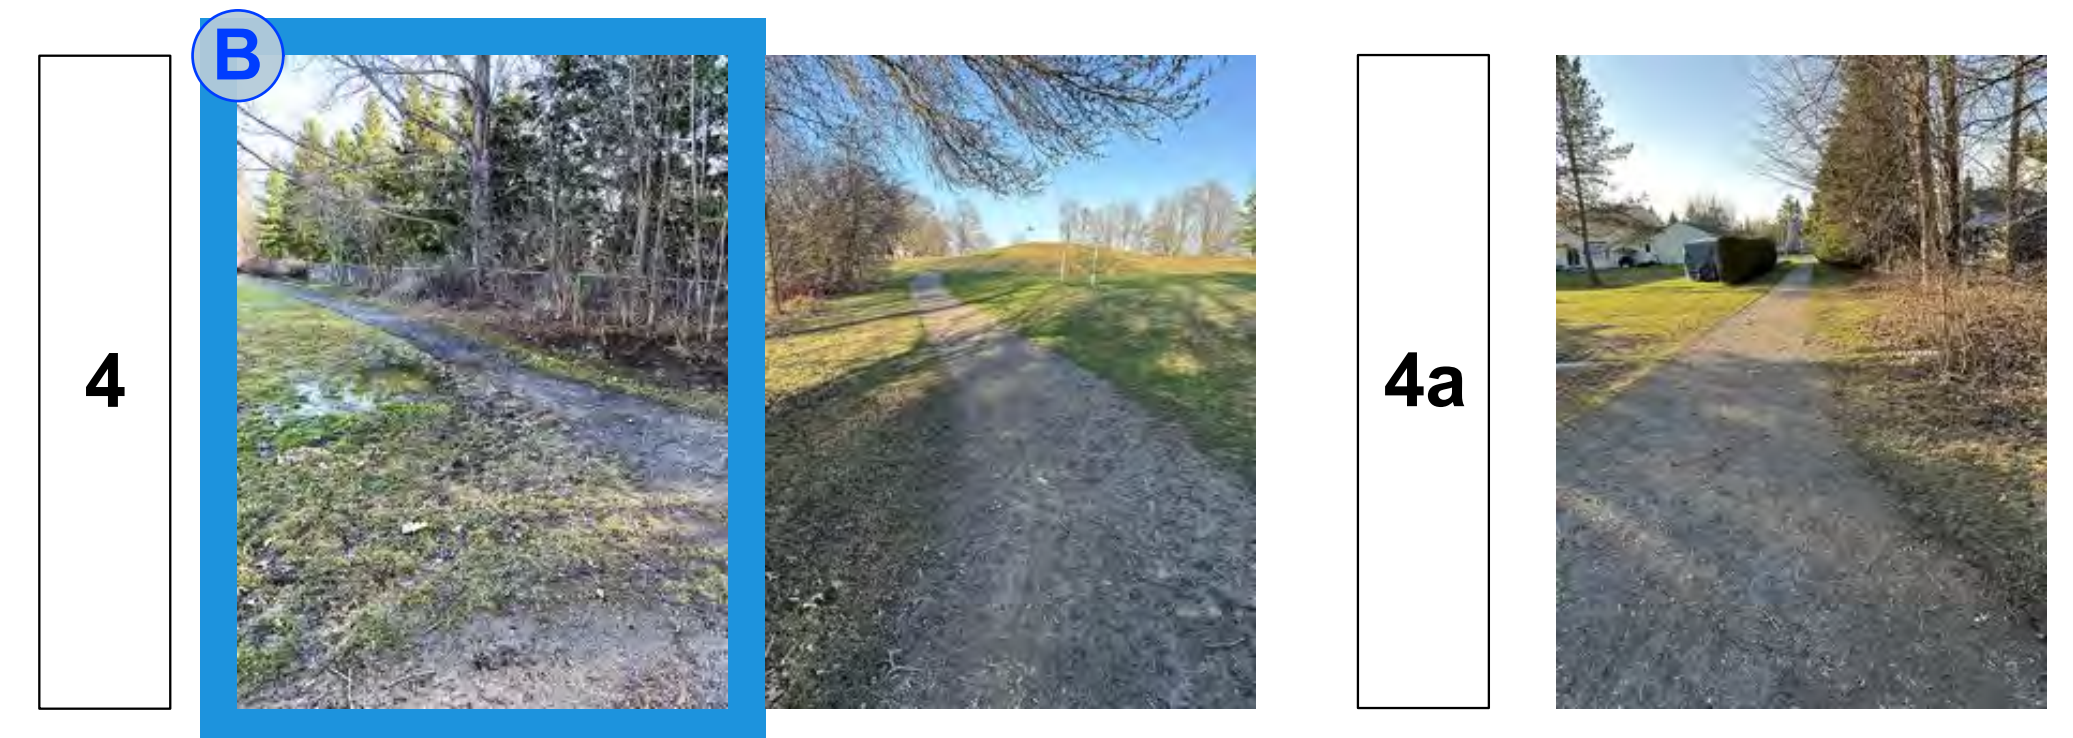
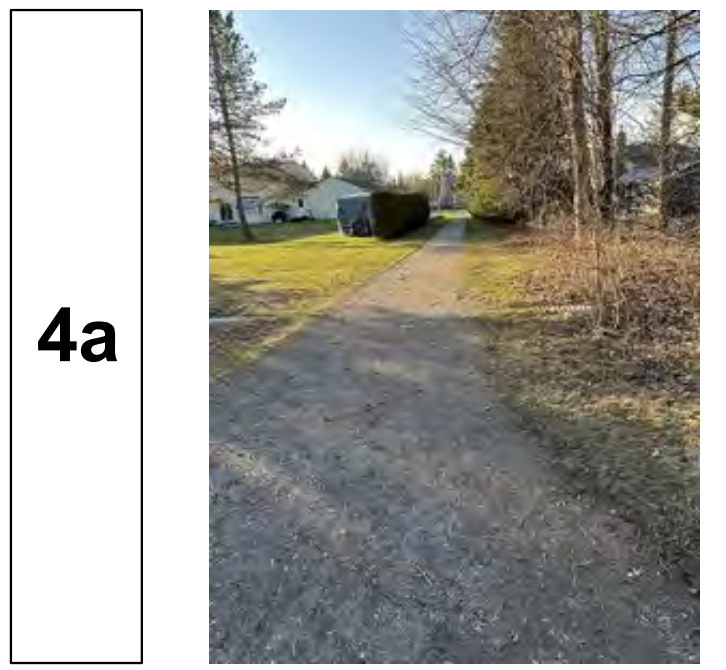
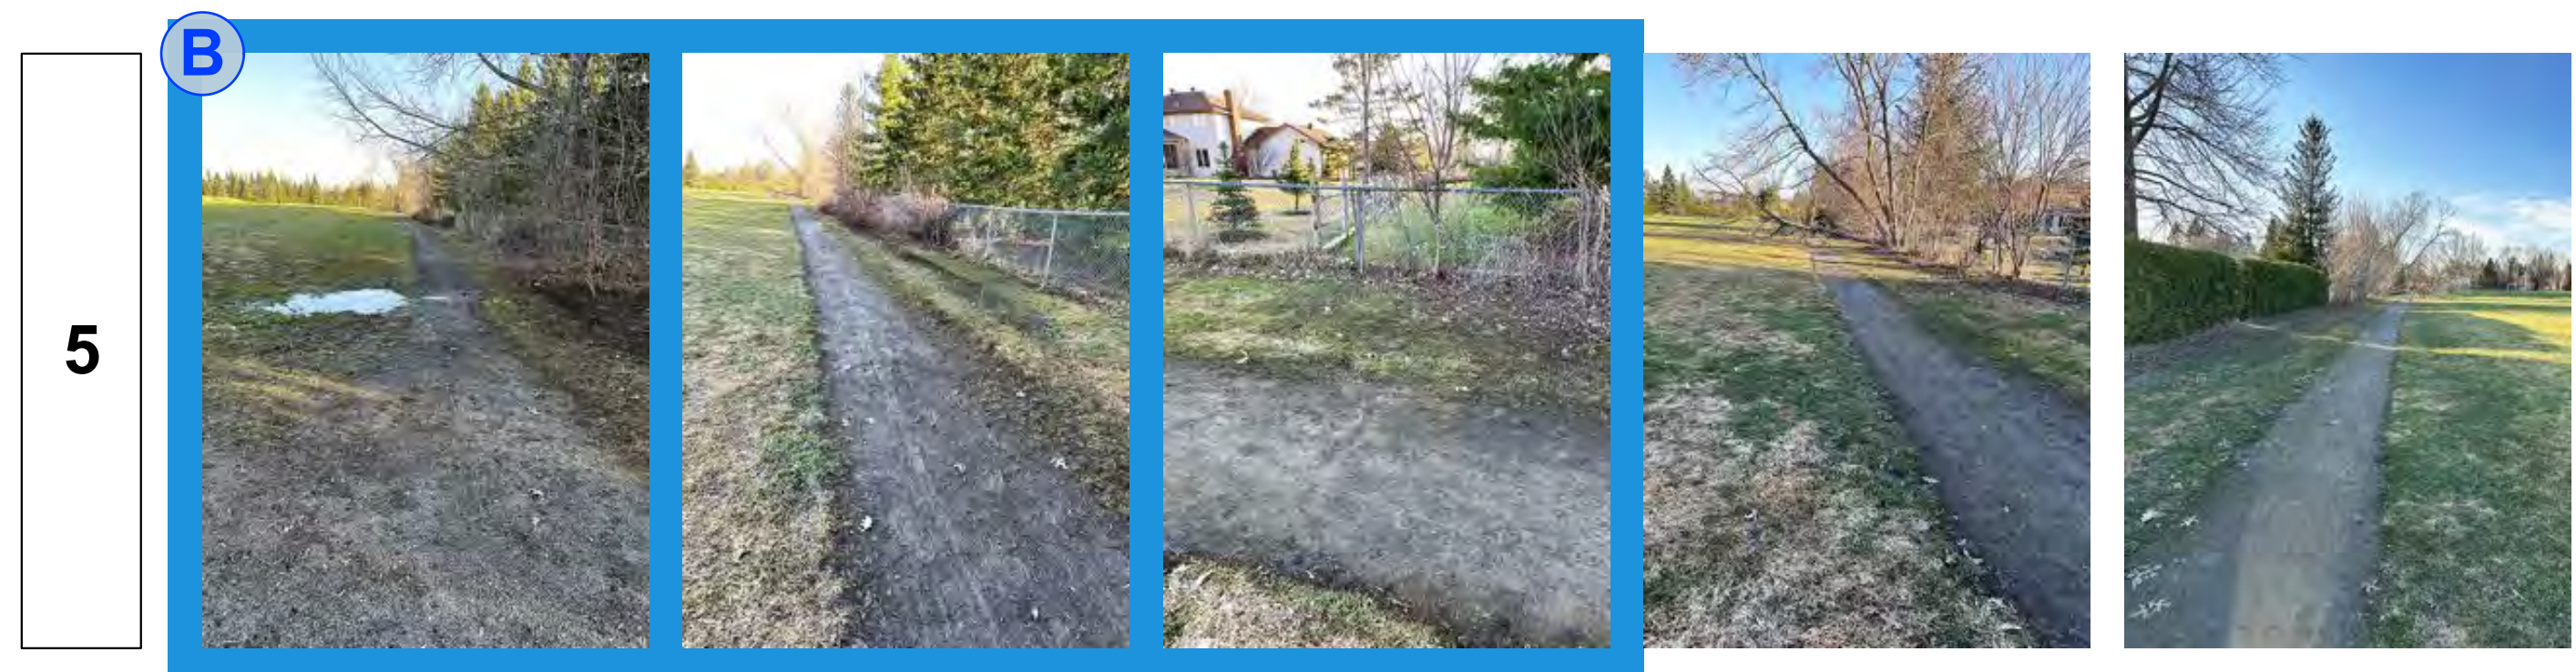
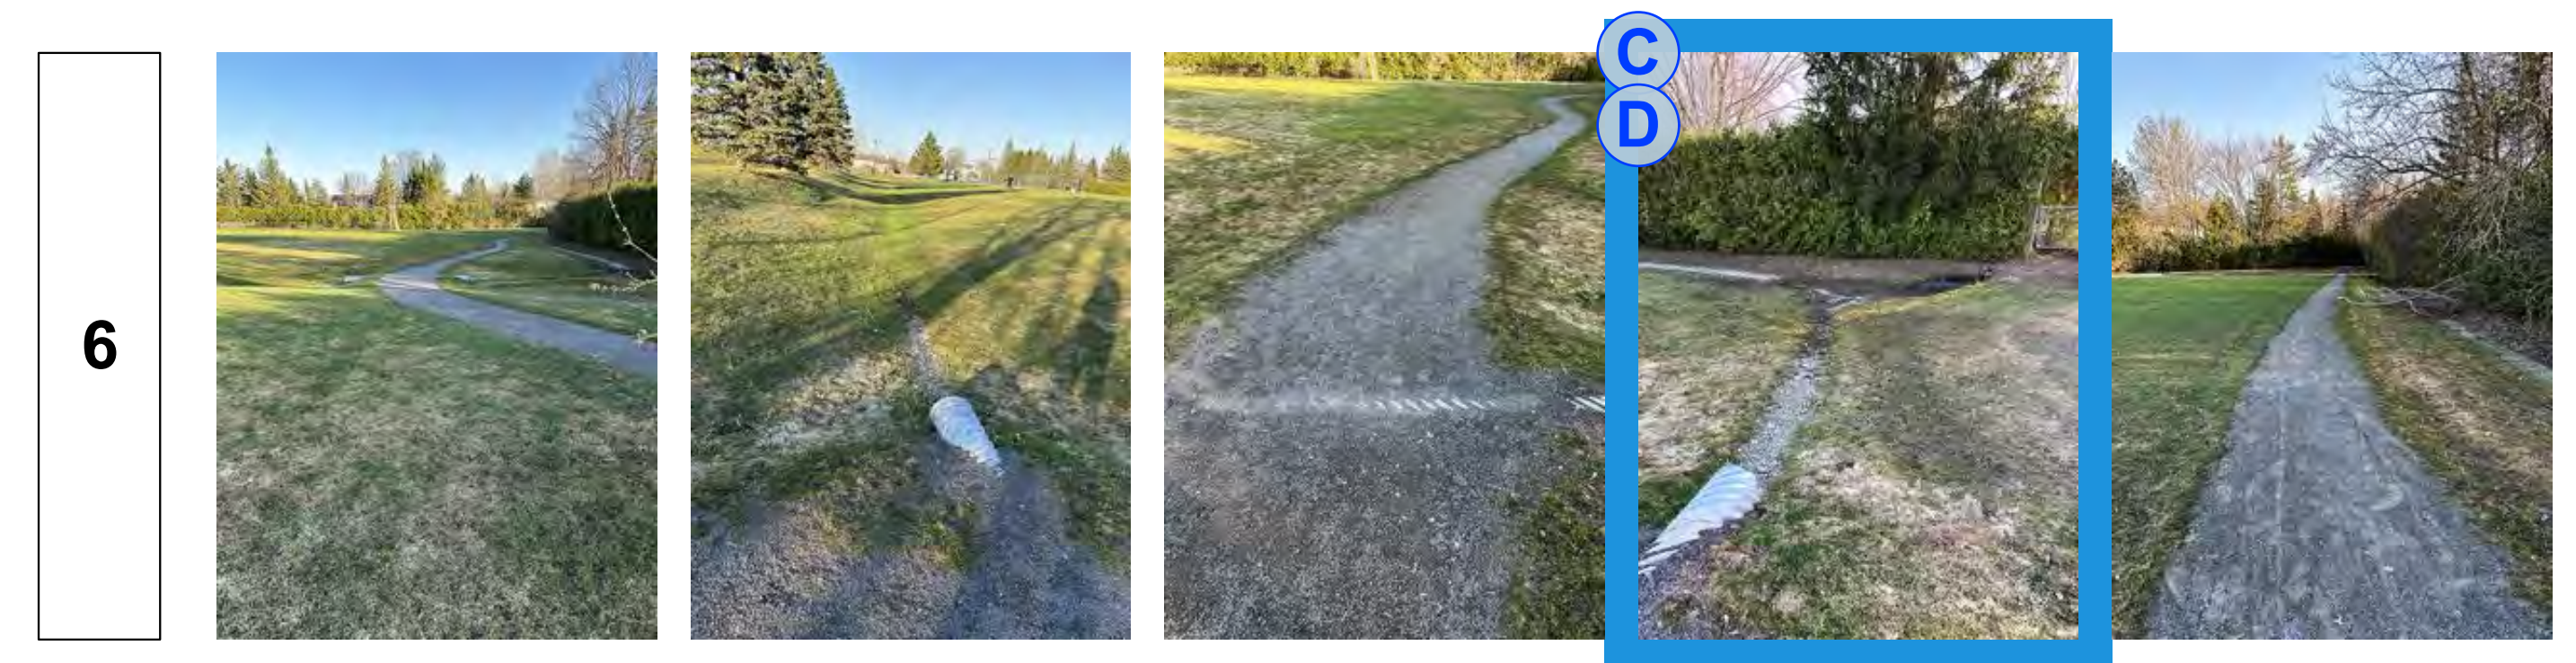
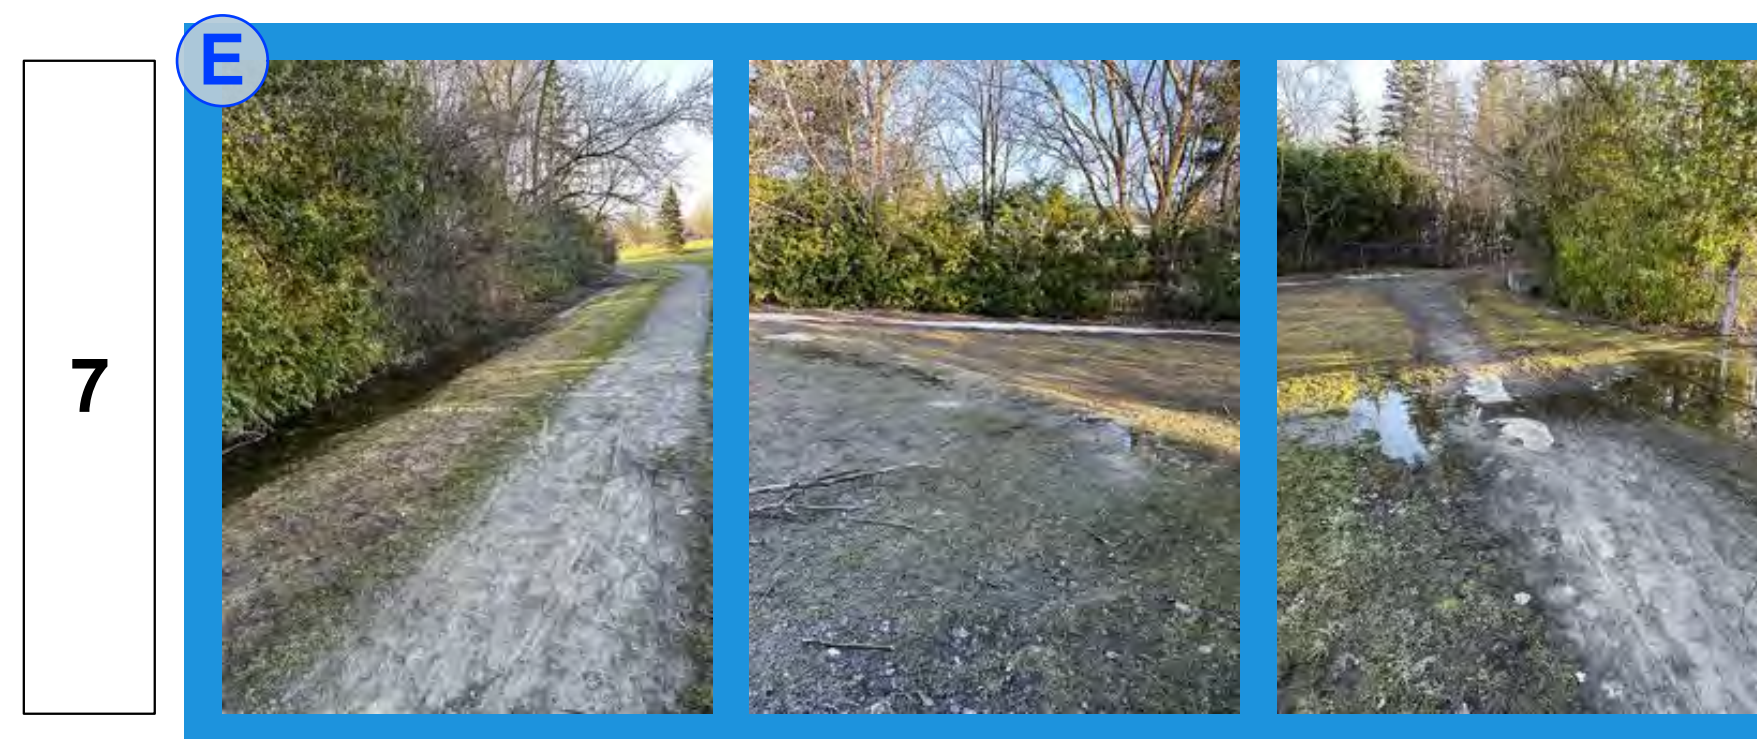
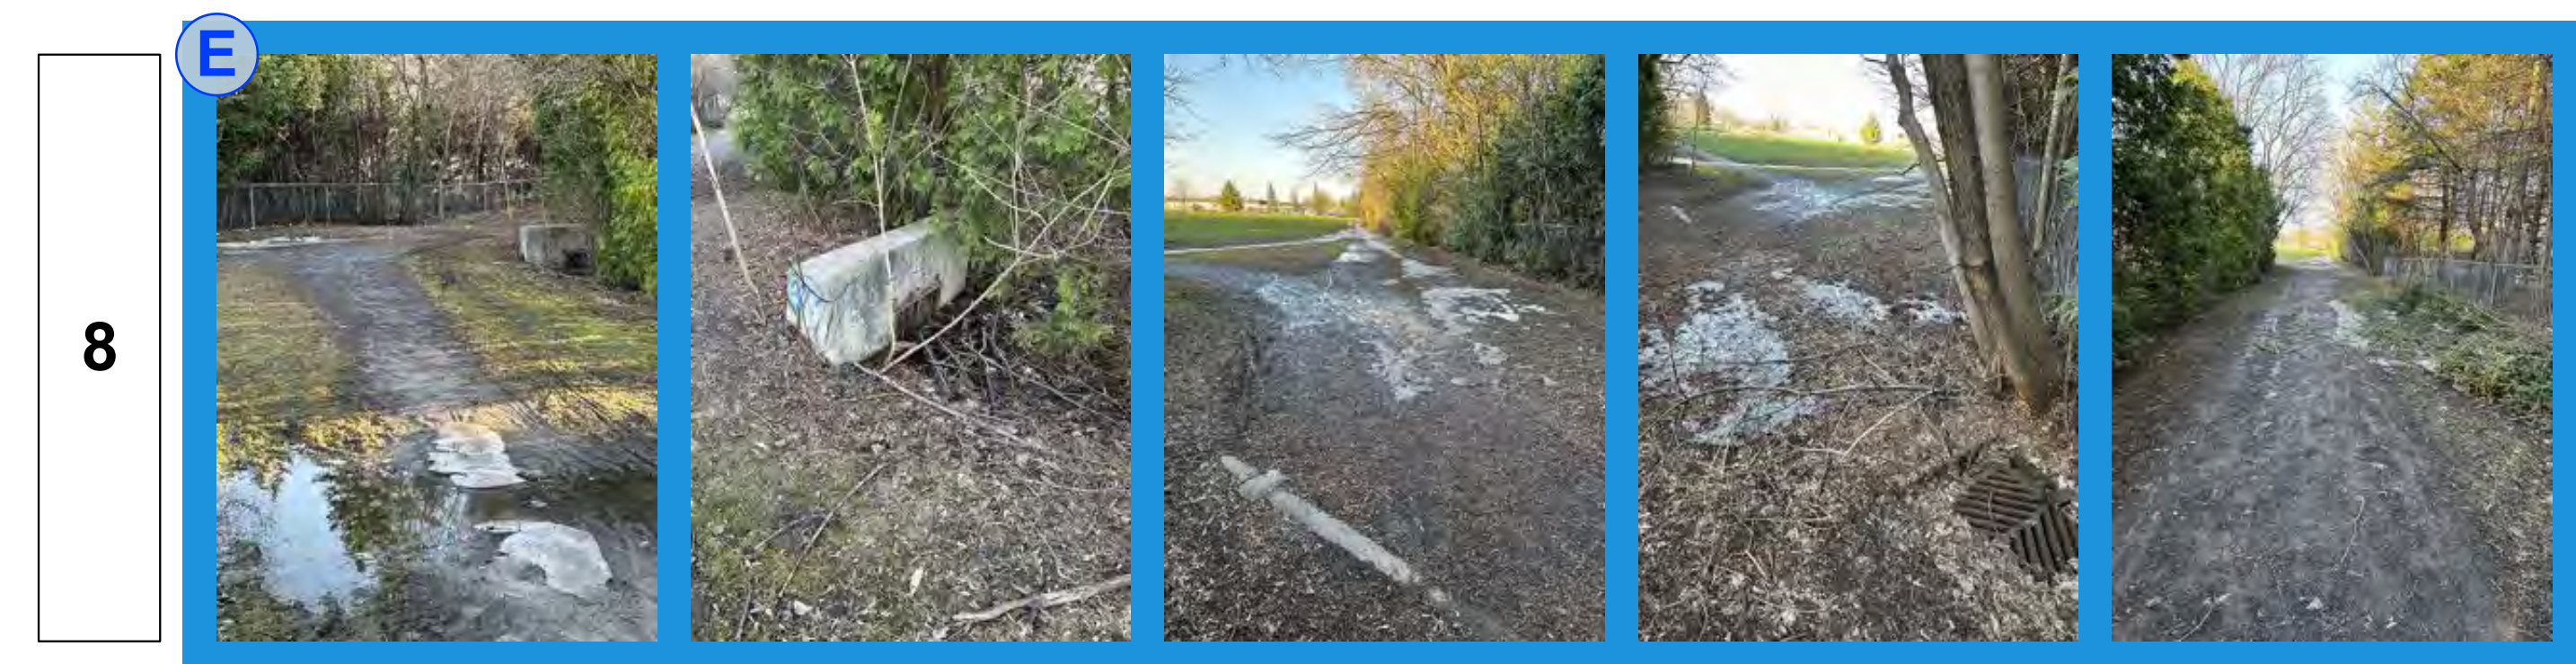
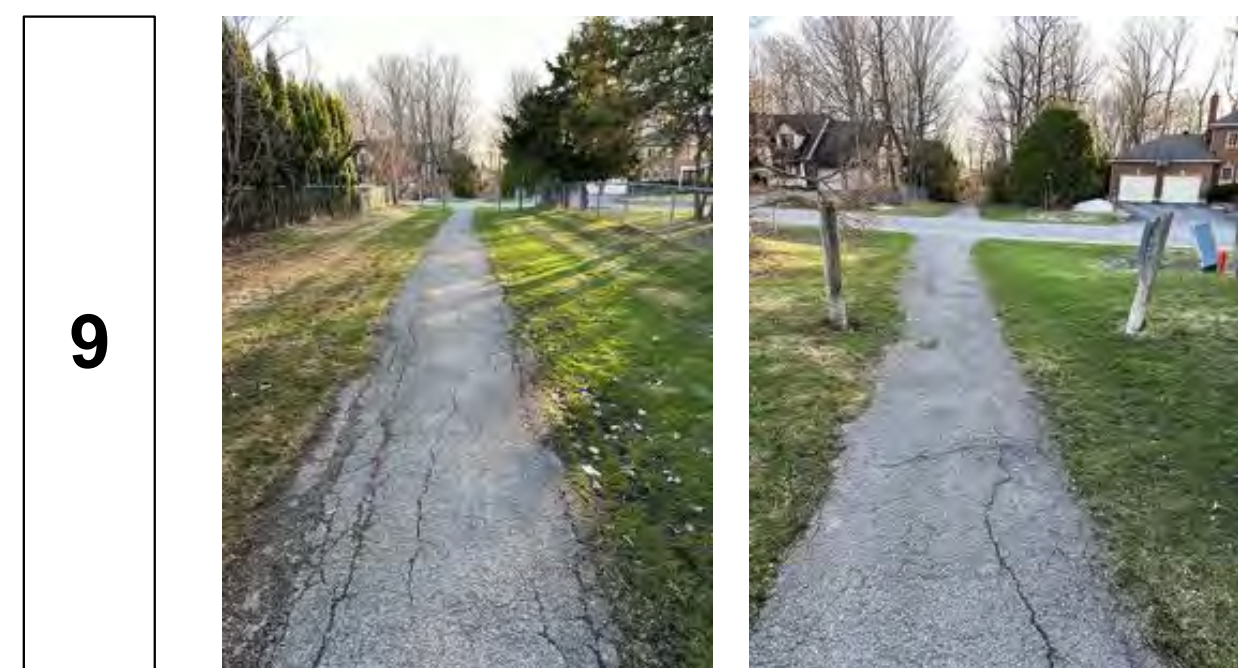
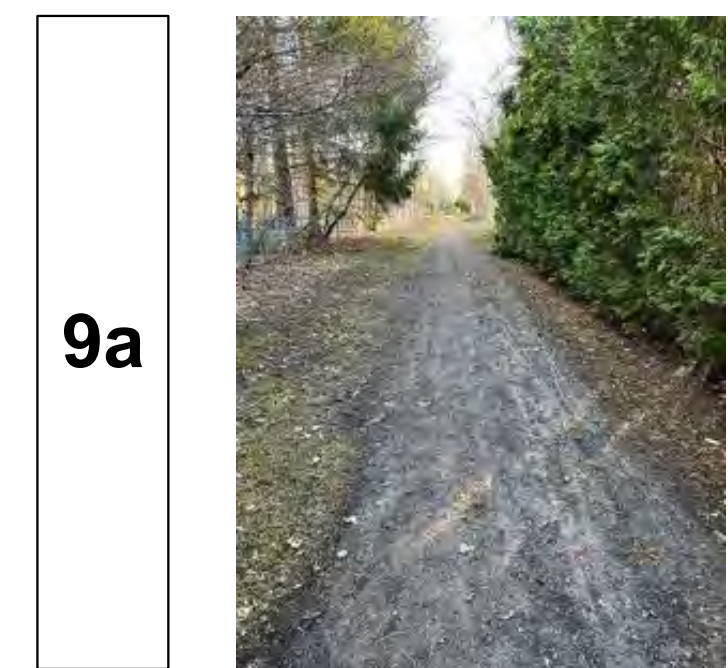
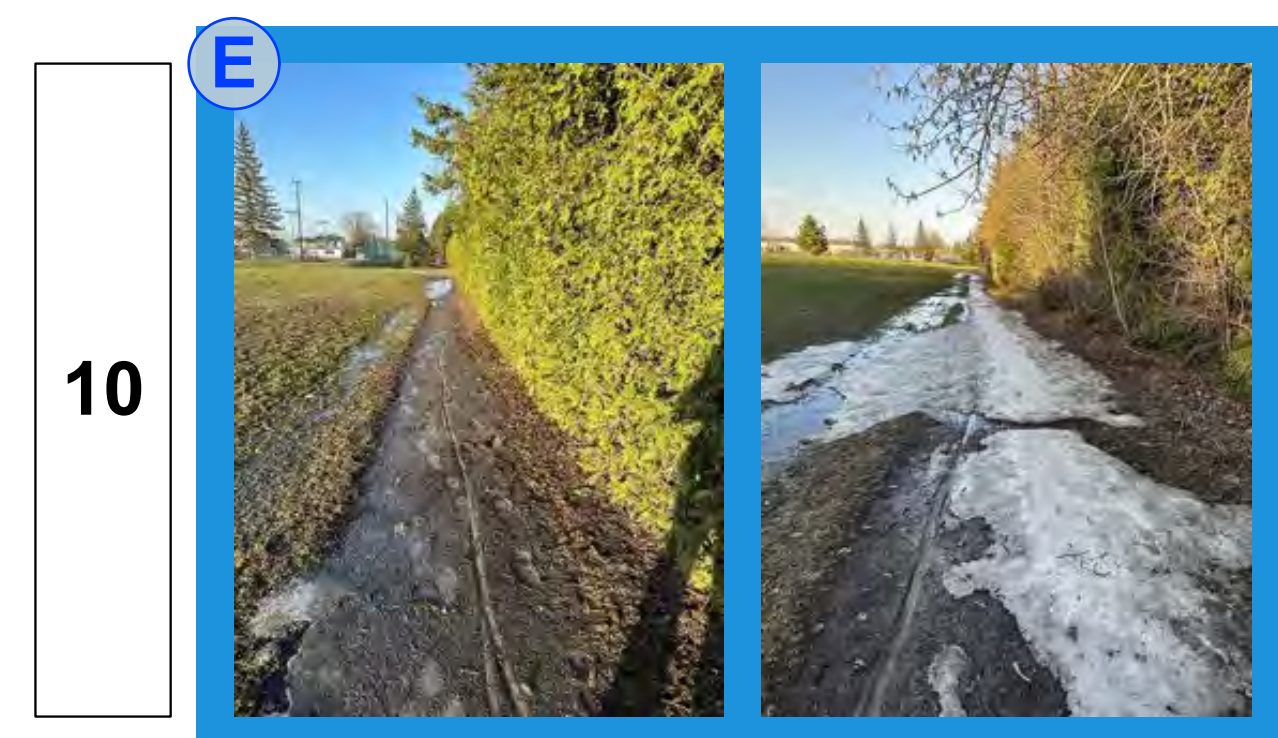
LOW AREAS

- 1 Entrance at Beaverwood Road: Small section of asphalt at road - in poor shape, not accessible. Bollards in poor shape.
- 2 Stonedust path 1.2-1.5 m wide upgraded here, in fairly good shape.

- 3 Erosion down path and at path intersection (low spot / not draining at intersection).
- 4 Very low and wet area (not draining).
- 5 Narrow path, shallow swale at property line (not draining).

- 6 Culvert at bend in path. Sump pump from adjacent house outlets here. Granular swale at culvert and extends south. Path ±900mm wide.
- 7 Swale overflows onto pathway.

- 8 Box end type drain - blocked or no slope? Culvert exposed on path, ends into Catch Basin. Water is not flowing.
- 9 Entrance at Beaverwood Road (west): Small section of asphalt at road - in poor shape, ±1.0 metre in width.

- 10 Section very wet, still snow here where most other places has melt. Swale not well defined, not draining. Lowest point at south end.
- 11 Low point and wet at bend in path, no drainage
