MCPRA MANOTICK CENTENNIAL PARK PATHWAY ENHANCEMENT PROJECT

Ruhland & Associates Ltd. have been retained to review the pathway systems within Centennial Park and connections to the wider neighbourhood. Site visits were undertaken in April and May of 2023 to assess the conditions of the existing pathways.

MANOTICK CENTENNIAL PARK - PATHWAY UPGRADES

Dr Leach Drive, Manotick

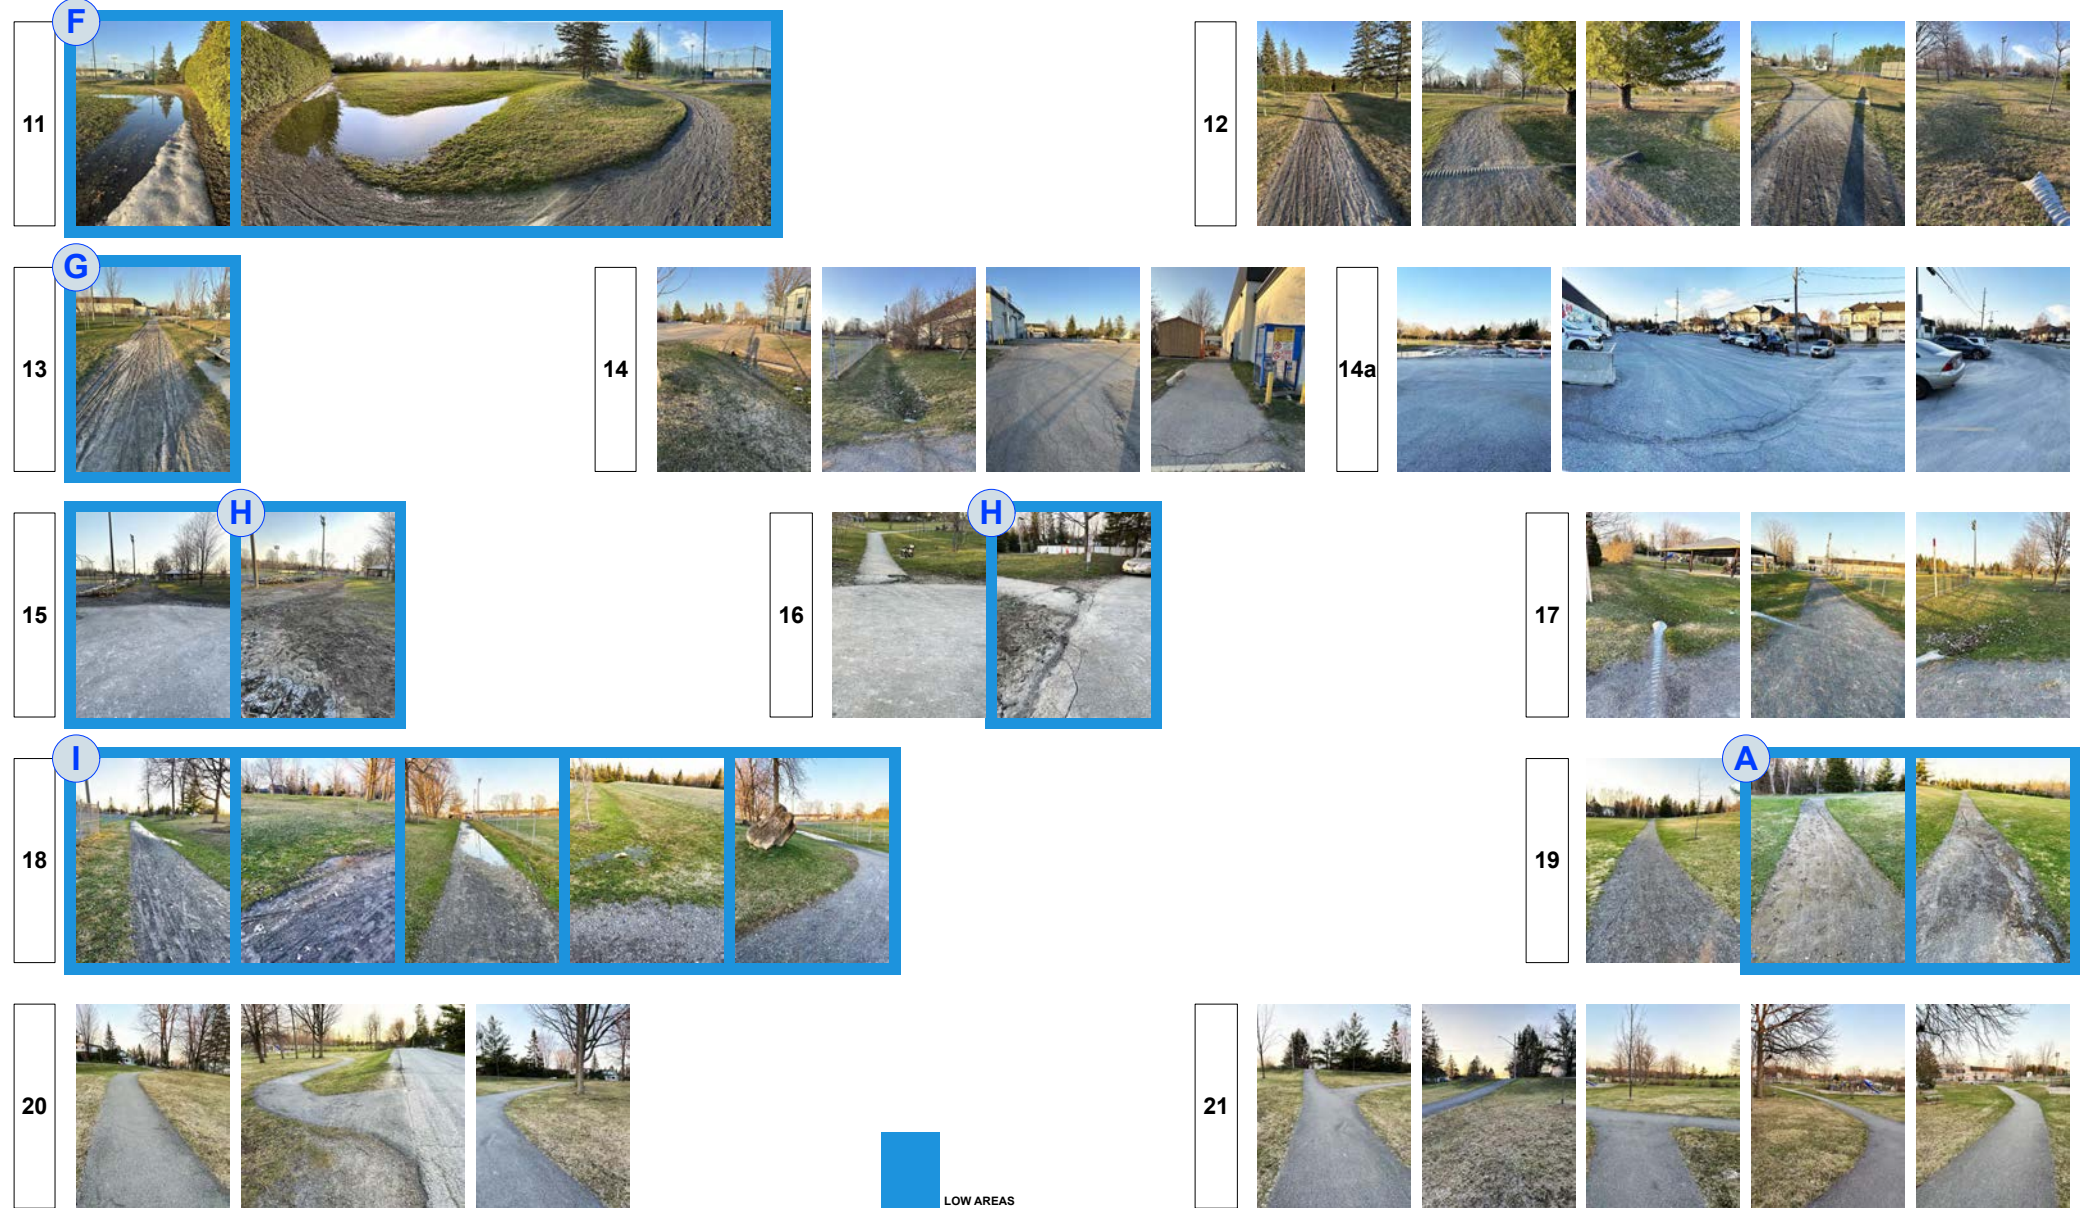
INVENTORY PHOTOS

- 1 Entrance at Beaverwood Road: Small section of asphalt at road - in poor shape, not accessible. Bollards in poor shape.
- 2 Stonedust path 1.2-1.5 m wide upgraded here, in fairly good shape.

- 15 Large low area behind addition - across pathway. Ground very uneven.
- 16 Broken asphalt, uneven ground at path junction.
- 17 Culvert exposed at pathways, drier here between ball diamonds.
